METIS HOMES

SAFETY ALERT

NO. 1

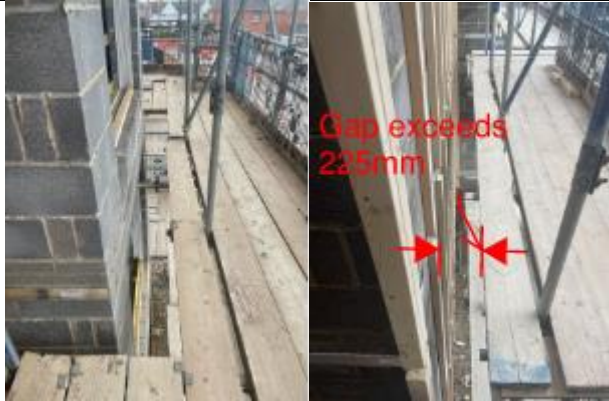
Alert date:	23 rd August 2021
Condition:	Inner board removed from scaffold platform to facilitate access for the cladding works, resulting in a gap between the internal scaffold board and building façade exceeding the permitted 225mm
Resulting risk:	Fall from height (but more likely to manifest in abrasion to limb)
How identified:	MSAFE safety monitoring visit
Condition supporting commentary:	<p>Scaffold Does the scaffold appear free from obvious defects?</p> <p>Action Raised Internal scaffold board has been removed for the installation of stud work to receive the cladding. Alternatively prevent access to upper lifts of scaffold until gap is closed by permanent cladding.</p> <p>Risk of injury/fall where gap exceeds 225mm.</p>
Condition supporting photos:

Relationship between condition and work being performed:	Space required between the scaffold and building, to enable the long lengths of timber, sheets of OSB sterling board & steel cladding sheets to be fed between the scaffold lifts and fixed vertically to the building, whilst still maintaining a safe working platform
Corrective action (options & selected):	Install internal guard rail or reduce gap to below 225mm. Not practical to install an internal guard rail as this would obstruct the access for the framework materials & cladding, so the gap was reduced to below the required 225mm by adjusting the transoms and clipping an additional section of timber in place (see picture below)
Corrective action supporting photos:

Preventative action:	(i) Consider requirement for access for installing cladding in more detail pre-start, in conjunction with scaffolding and carpentry sub-contractors; (ii) consider using telescopic transoms to allow easier removal of inner board whilst ensuring gap is compliant; (iii) ensure sub-contractor RAMS adequately address fixing of cladding; (iv) update scaffolding specification to require adaption to suit installation of cladding, tile hanging & external rendering in order to facilitate safe system of work
