METIS HOMES

SAFETY ALERT

NO. 5

Alert date:	5 th July 2023
Condition:	Use of a Paslode (or similar) nail gun

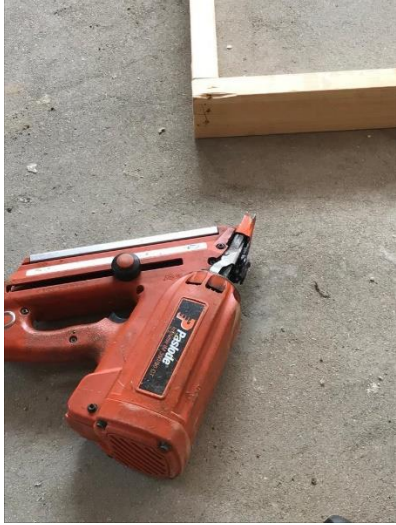
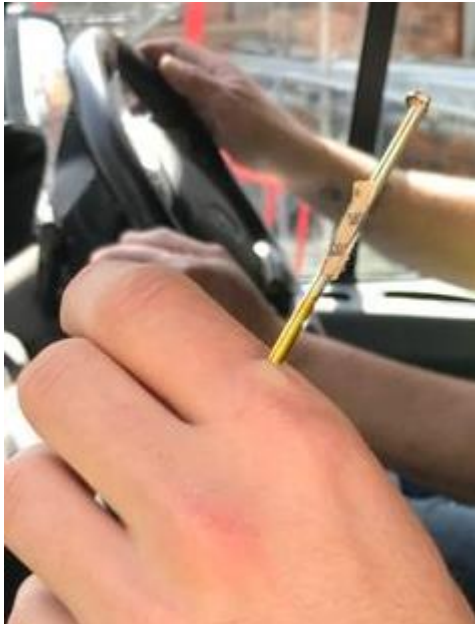
Resulting risk:	90mm nail passed through timber into hand of operator

How identified:	Site accident record - operator sustained injury requiring hospital treatment

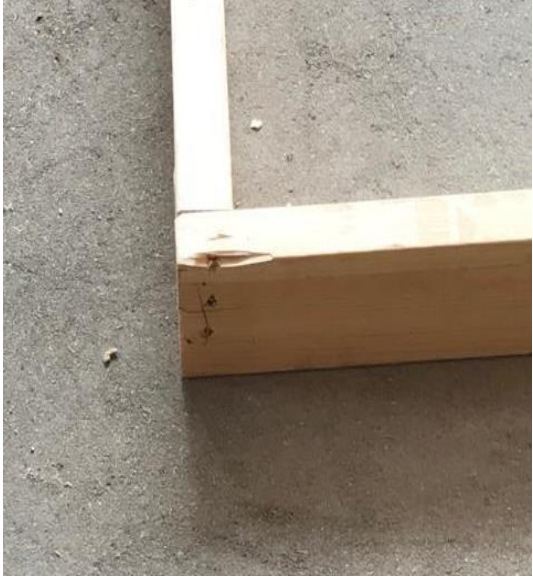
Condition supporting photos:

Operator's positioning of nail gun was too close to edge of timber, as can be seen from this photo
Work being performed:	Forming studwork partition on floor before offering up into vertical position	
Relationship between condition and work being performed:	Possible complacency led to the gun being discharged too close to the edge of the timber, causing the nail to deflect and pass through the external angle of the timber and into the operator's left hand being used to hold the studwork steady	
Corrective action (options & selected):	Do not discharge nails within close proximity to the timber edge. Use a jig to secure the workpiece where practical. Ensure free hand and any other body part is at safe distance and not within the direction of travelling nail

- Ensure appropriate risk assessment for use of nail gun has been read and understood
- Ensure appropriate method statement for use of nail gun has been read and understood
- Method statement should include reference to gun manufacturer user and safety manual
- Use manufacturer web-based training as TBT refresher <https://training.paslode.co.uk/courses/paslode-end-user-training/>
- Ensure required PPE is available and enforce use
- Ensure operator can demonstrate relevant experience in using a nail gun
- Avoid placing slave hand too close to zone of impact
