# METIS HOMES

## SAFETY ALERT

## NO. 3

<b>Alert date:</b>	<b>13<sup>th</sup> October 2022</b>
<b>Condition:</b>	<b>Operative working from top rungs of stepladder</b>
<b>Resulting risk:</b>	<b>Fall from height, due to unsuitability of access equipment for the task height, over-reaching and inability to maintain 3 points of contact with ladder</b>
<b>How identified:</b>	<b>MSAFE safety monitoring visit</b>
<b>Condition supporting commentary:</b>	<p><b>Photo Notes / Actions:</b> Ladder too short.</p> <p>Item discussed with the operative and Site Manager at the time of inspection.</p> <p>As discussed with the Site Manager, step ladders are being used where scaffold tower/podium steps could be used as a safer alternative.</p> <p>Where ladders are used, ensure a risk assessment/permit demonstrates they are appropriate to use, for example work is of short duration and 3 points of contact can be maintained.</p>
<b>Condition supporting photos:</b>	<div data-bbox="453 1435 927 2085">

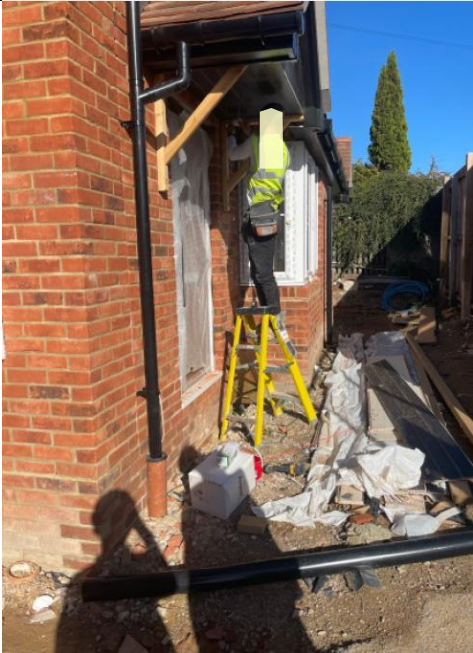
</div> <p><b>Operative needs to work from top two rungs of stepladder in order to reach workface</b></p> <p><b>Unsuitable choice of access equipment for the task</b></p> <p><b>Ground has not been cleared of debris to provide level ground to foot stepladder on</b></p>

<b>Work being performed:</b>	<b>Electrician fitting outside light to soffit of porch</b>
<b>Relationship between condition and work being performed:</b>	<b>Suitable access equipment was not easily / readily available so operative used own step ladders</b>
<b>Corrective action (options &amp; selected):</b>	<b>Stepladders should only be used for low risk short duration work (e.g. 30 mins) and in the following conditions:</b> <ul style="list-style-type: none"><li>- Ladder can be footed securely on level ground</li><li>- Ladder is in good condition and sized appropriately so that operative can reach the work face whilst maintaining 3 points of contact with 3 clear steps</li><li>- No over-reaching</li><li>- Ladder is Class 1 and / or BS EN 131 compliant</li></ul>
<b>Corrective action supporting photos:</b>	<p>The diagram shows a silhouette of a person on a step ladder, holding a power drill. A circular callout at the top left states 'MEETS BRITISH OR EUROPEAN STANDARD'. Red callout boxes point to various safety features: 'RIGHT HEIGHT FOR JOB' (pointing to the person's reach), 'GOOD GRIP' (pointing to the handhold), 'NO OVER-REACHING' (pointing to the person's arm position), 'LADDER UNDAMAGED' (pointing to the ladder structure), 'FRONT-ON' (pointing to the person's stance), 'FIRM AND LEVEL BASE' (pointing to the ladder's feet), 'FOUR NON-SLIP FEET' (pointing to the ladder's base), 'CLEAN STEPS' (pointing to the ladder's rungs), and 'FLAT SHOES' (pointing to the person's feet).</p>

<b>Preventative action:</b>	<p><b>Avoid use of stepladders for longer duration work and provide safer alternative means of access such as podium steps or mobile scaffold tower set to correct height</b></p> <p><b>Check sub-contractors' RAMS identify where stepladders may be intended to be used and consider whether safer alternative means are an option</b></p> <p><b>Ensure step ladders are appropriately sized for the task so that operative can maintain 3 points of contact and does not need to overreach or work from top 3 steps</b></p> <p><b>If stepladders are used, ensure immediate surrounding area cleared of debris to allow footing on solid and level ground</b></p>
<b>Alert prepared by:</b>	<b><i>Andrew Sinclair</i></b>
