# METIS HOMES

## SAFETY ALERT

## NO. 6

<b>Alert date:</b>	<b>29<sup>th</sup> November 2023</b>
<b>Condition:</b>	<b>Groundworker setting out kerb line with road pins</b>
<b>Resulting risk:</b>	<b>Metal pin was hammered into live HV underground cable</b>
<b>How identified:</b>	<b>Site accident records - operative received an electrical shock to left arm</b>
<b>Condition supporting photos:</b>

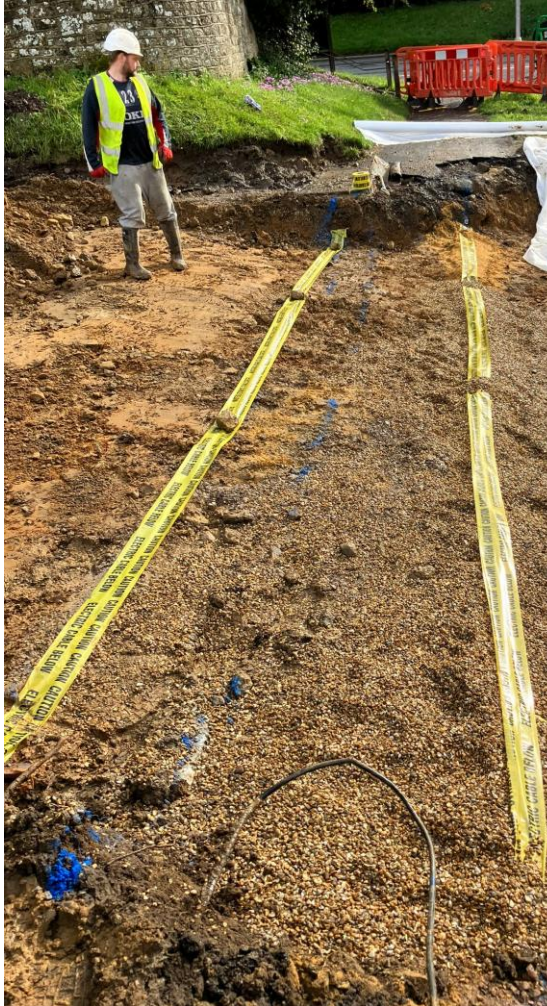
<p>Site had been prepared and marked to show that known live services were in vicinity</p>
<b>Work being performed:</b>	<b>Setting out kerb line for completion of access bell-mouth</b>

<b>Preventative action:</b>	<ul style="list-style-type: none"><li>- <b>Ensure Permit to Dig procedures are properly adhered to and cables are always located prior to any ground penetrations</b></li><li>- <b>Re-mark ground above utilities locations as necessary to ensure hazard is always visible</b></li><li>- <b>Avoid having metal road pins on site so that they cannot be used</b></li></ul>
<b>Alert prepared by:</b>	<b><i>Andrew Sinclair</i></b>

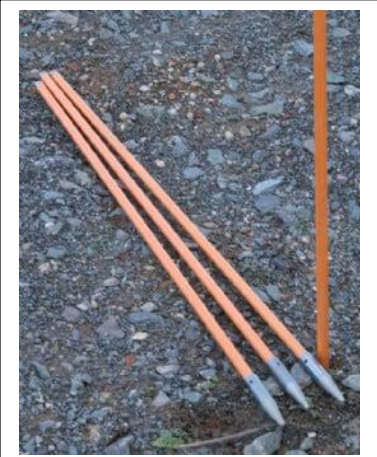
</div></div> <p data-bbox="496 1487 799 1518">Non-conductive road pin</p> <p data-bbox="959 1487 1270 1518">Non-penetrating road pin</p>
