METIS HOMES

SAFETY ALERT

NO. 4

Alert date:	12th December 2022
Condition:	Operative using telehandler skip

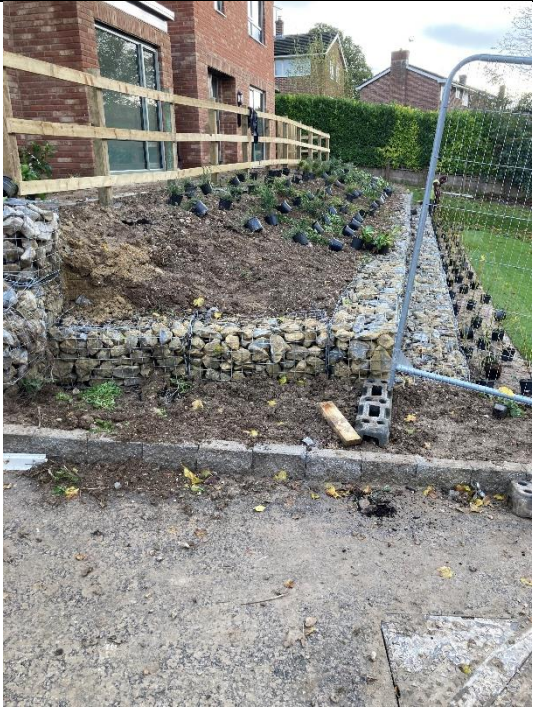
Resulting risk:	Skip slid off forks narrowly missing a nearby operative
How identified:	Site accident record - operative who jumped out of the way of the skip fell and sustained injuries
Condition supporting photos:

<p>Operative was standing in readiness to shovel soil out of teleskip on sloped area at front of plot</p>

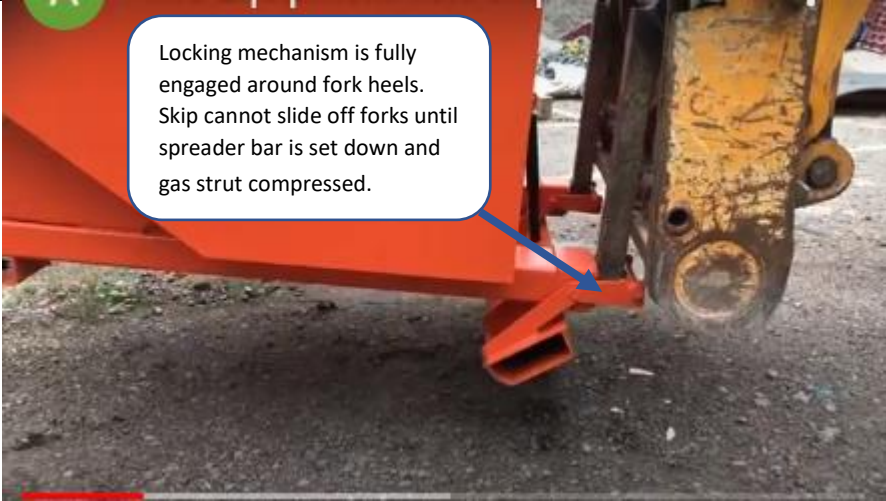
Work being performed:	Landscaping to front of plots
Relationship between condition and work being performed:	As part of the exercise, tele skip had been used like a digger bucket to pick up and move soil to work area. This may have caused issues which resulted in the locking mechanism becoming clogged up and the tele skip not fully engaging on the fork heels. Rather than tip all contents of the skip on the work area, the injured operative was standing nearby ready to use shovel to control the amount of soil leaving the skip
Corrective action (options & selected):	Operator to check that locking mechanism of tele skip has been fully engaged around fork heels after lifting off ground (as this is what engages the locking mechanism) but prior to moving off
Corrective action supporting photos:

Preventative action:	<ul style="list-style-type: none">- Tele skips should <u>never</u> be used like a digger bucket- Tele skips should be filled by other means (e.g. digger loading from stockpile or dumper before being lifted by the forks attachment)- Operatives should not stand adjacent to lifting plant or suspended loads- Tele skips only to be manoeuvred by suitably experienced operatives who carry out post-lift but pre-

travel checks to ensure locking mechanism is properly engaged
Alert prepared by:	<i>Andrew Sinclair</i>
