## SAFETY ALERT

## NO. 2

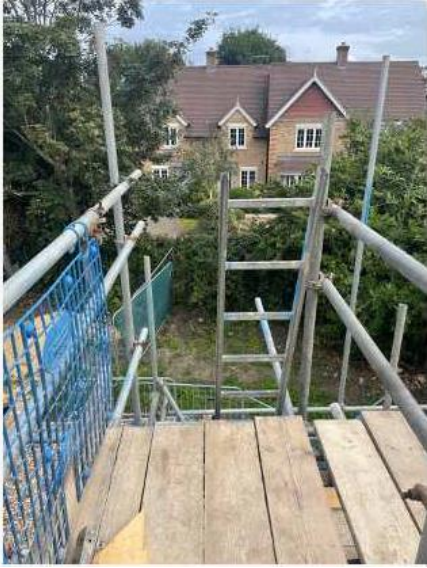
<b>Alert date:</b>	<b>29<sup>th</sup> September 2021</b>
<b>Condition:</b>	<b>Ladder access orientated face on (rather than side on) to scaffold platform and with no ladder gate.</b>
<b>Resulting risk:</b>	<b>Fall from height, either from difficulty with mounting or dismounting the ladder or through having a non-identified leading edge to the scaffold platform</b>
<b>How identified:</b>	<b>MSAFE safety monitoring visit</b>
<b>Condition supporting commentary:</b>	<p>9.04 Ladders Where ladders are used for access, do they extend sufficiently to a safe landing area?</p> <p><b>Action Raised</b> Recommend ladder is positioned side on to the landing area to allow for easy access when mounting/dismounting the same.</p> <p>Also, install ladder gate to further prevent falls from the leading edge of the landing area.</p>
<b>Condition supporting photos:</b>	<div data-bbox="456 1424 884 1989">

</div> <p><b>Ladder fixed face on to scaffold platform, requiring operatives to 'step around' ladder to mount and dismount</b></p> <p><b>No ladder gate installed to identify leading edge of scaffold platform</b></p>

<b>Work being performed:</b>	<b>Superstructure masonry and roof construction</b>
<b>Relationship between condition and work being performed:</b>	<b>Intent to provide safe access to upper lift of scaffolding for bricklayers and carpenters for ongoing superstructure works. Whilst not a prescriptive statutory requirement, side on ladder access is considered best practice and forms part of the NASC guidance</b>
<b>Corrective action (options &amp; selected):</b>	<b>Re-orientate ladder access to be side on to scaffold platform, in order to allow operatives to 'step off' ladder on to platform rather than having to 'step around'. Install ladder gate to identify leading edge of scaffold platform (see diagram below)</b>
<b>Corrective action supporting photos:</b>

<b>Preventative action:</b>	<b>(i) Update scaffolding specification to require arrangement/orientation of ladder access to be in accordance with NASC SG25:20 and include link to guidance (link provided below); (ii) review scaffold schedule with appointed scaffolding sub-contractor pre-start to establish whether there are any situations where ladder access compliant with NASC SG25:20 cannot be achieved; (iii) ensure particular scaffolding sub-contractor gang attending site is aware of the requirement for side on ladder access</b>

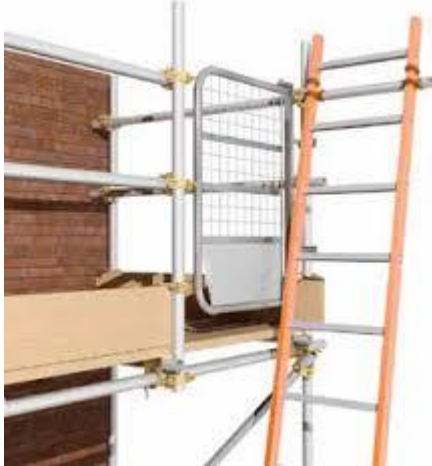
<p><b>Ladder oriented side on to scaffold platform</b></p> <p><b>Ladder gate installed to identify leading edge of scaffold platform</b></p>
